ITEM 2

ITEM 2: 126 North Westland Avenue 5/12/15 GHDC MEETING

Applicant requests approval for a patio roof extension that extends from the front door out into the front yard. The property is located at 126 North Westland Avenue, which is located in the Woodson Terrace Historic District.

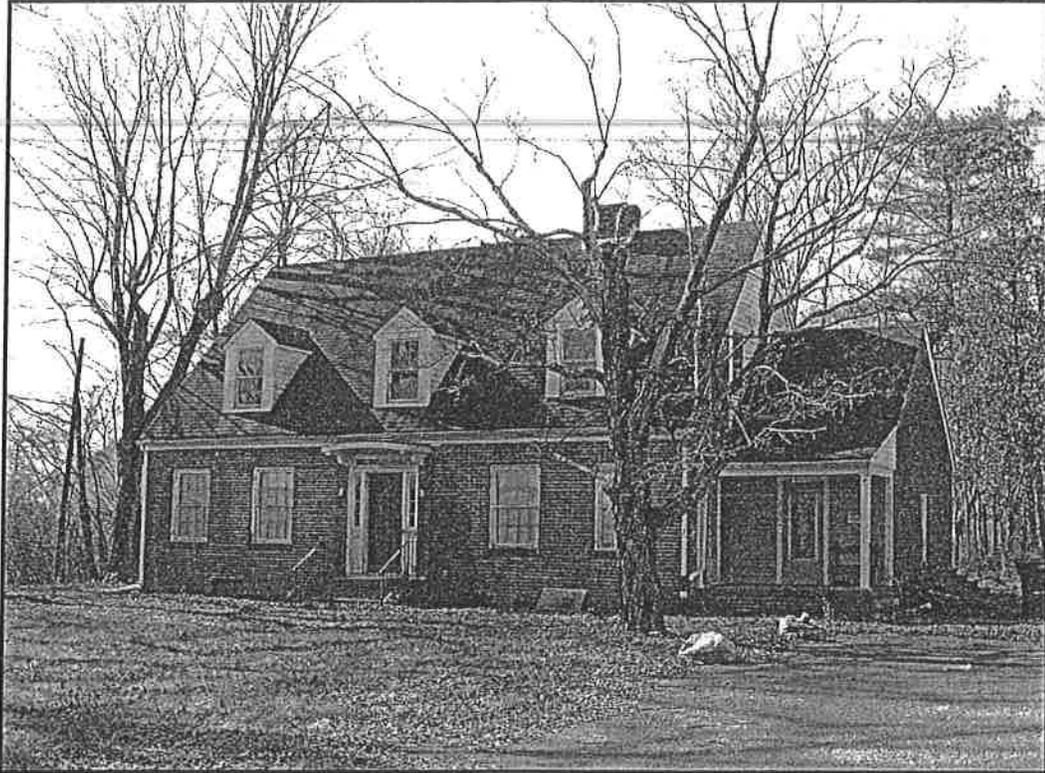
ATTACHMENT 2-2

At this location is a one-and a half story, Colonial Revival house. The house has a continuous poured concrete foundation, a side gable roof of asphalt shingles, an interior brick chimney and an exterior of brick veneer. On the main (E) façade is a brick patio covered with an arched canopy supported by wood brackets. The patio also has ca. 1960 wrought iron handrails. The main entrance has a ca. 1990 metal six-panel door

with an original five-light transom and four-over-one sidelights. The windows are four-over-four, six-over-six and eight-over-eight double-hung wood sash windows with brick sills. On the main façade are three gable roof dormers with aluminum siding and six-over-six wood sash windows. On the N façade is a gable roof lateral wing with aluminum siding and brick veneer, jalousie windows and an original fifteen-light glass and wood door. Aluminum siding and one rectangular louvered vent comprise the side gable fields. On the rear (W) façade is an original full-width wing.

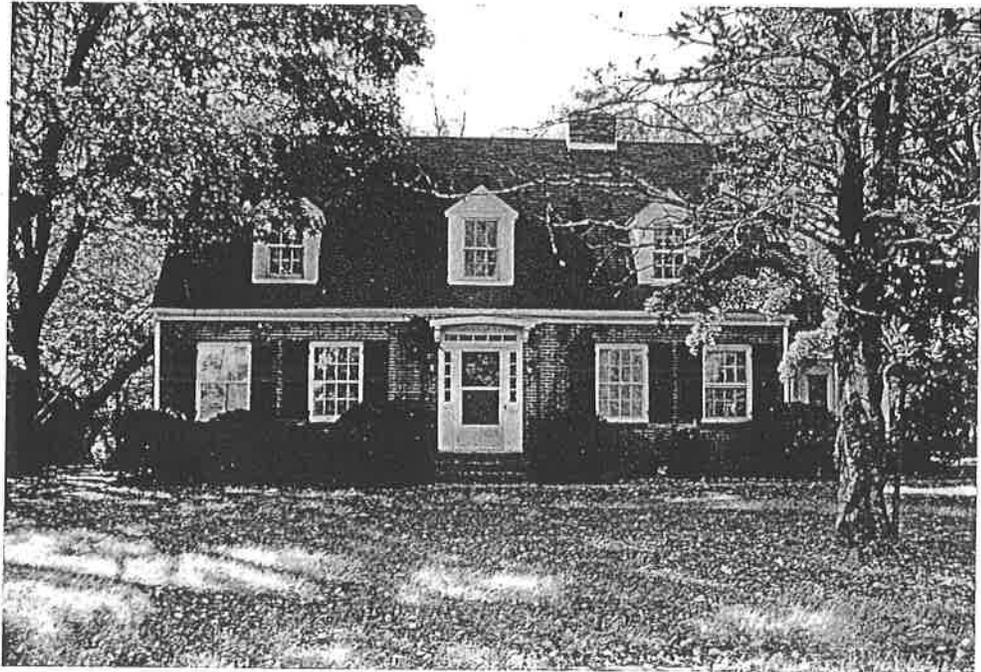
DESCRIPTION OF PROPERTY: Colonial Revival brick, 1 1/2 story,
3 front-facing dormers, 8 over 8 windows, sidelights
and transom, asphalt roof, circa 1935
